**ROV Drilling Operations for TN183-184 Cruise – Sept. 2005**  
**Chief Scientists: D. Kelley and J. Delaney - U. Washington**

R. Fuhrmann – ROV Drill Engineer - onboard  
P. Tucker – ROV Drill Engineer - onboard  
D. Fornari and M. Tivey – WHOI ROV Drill System  
November 30, 2005

Cruise Number: TN183-184

Drill Site: Juan de Fuca Ridge, Mothra/Endeavour Sites (hydrothermal vents)

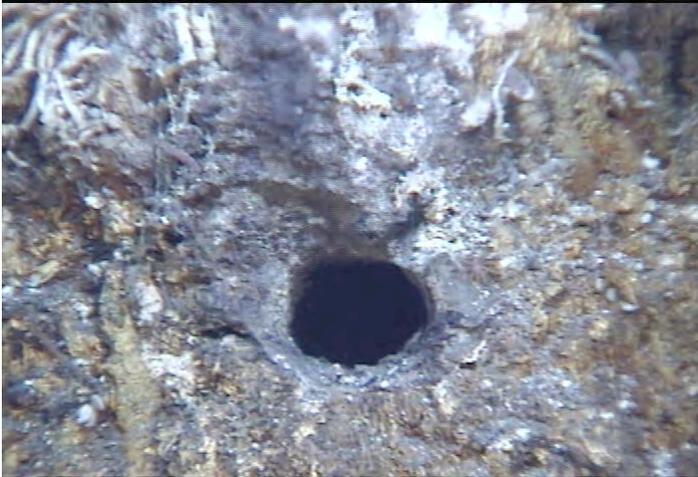
Frame grab #471: existing hole before reaming

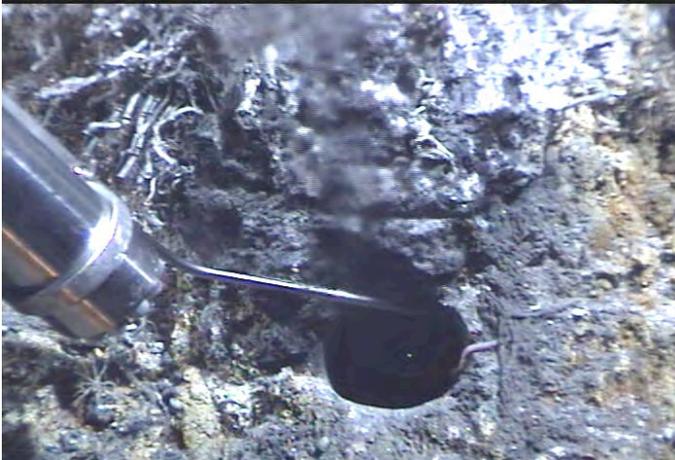
Frame grab #543: close-up shot of reamed drill hole, gas-tight sample being taken

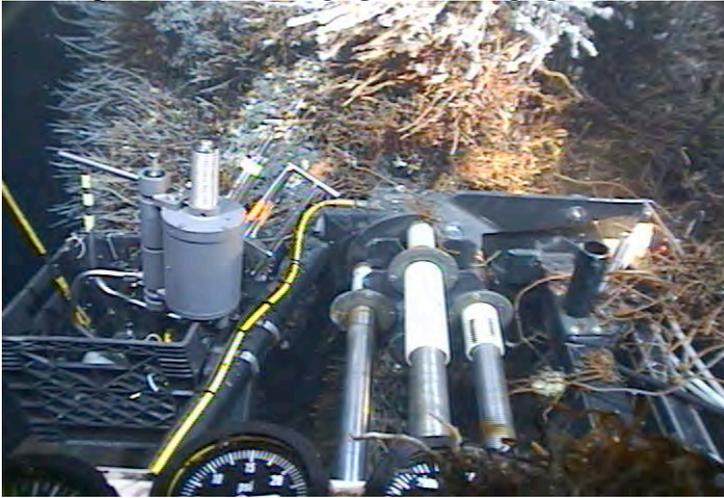
Frame grab #1285: setting up for drilling operation

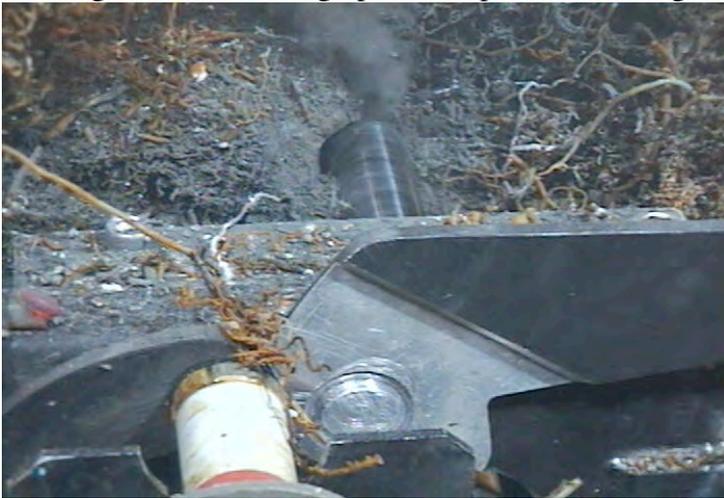
Frame grab #1308: coring operation (prior to reaming)

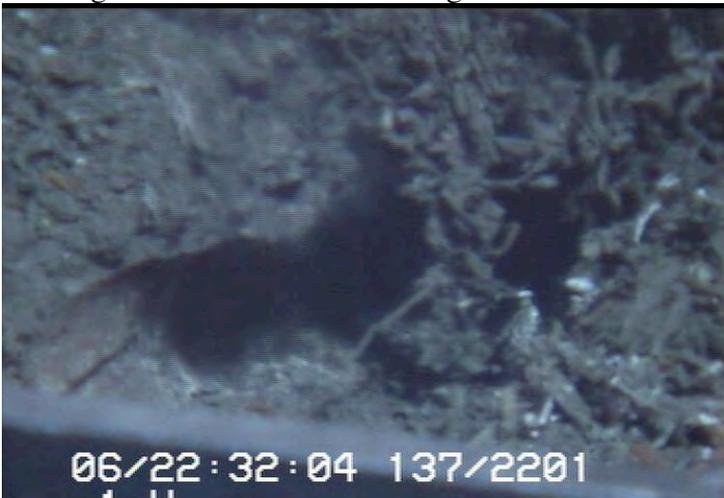
Frame grab #1312: hole after coring

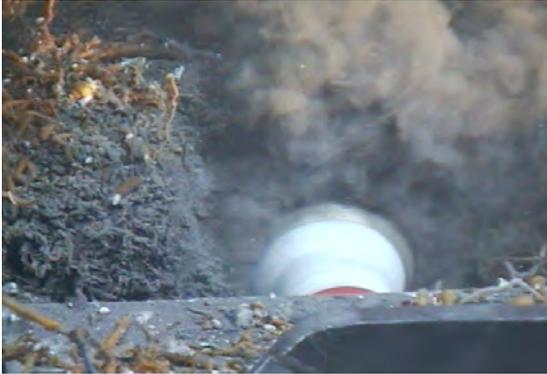
Frame grab #1319: reaming operation, beginning of cut

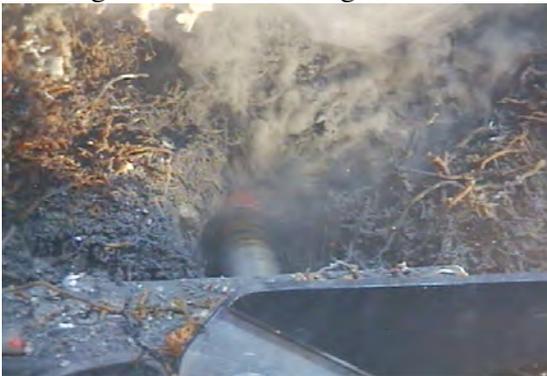
Frame grab #1324: reaming continued, ~3 inch depth of cut

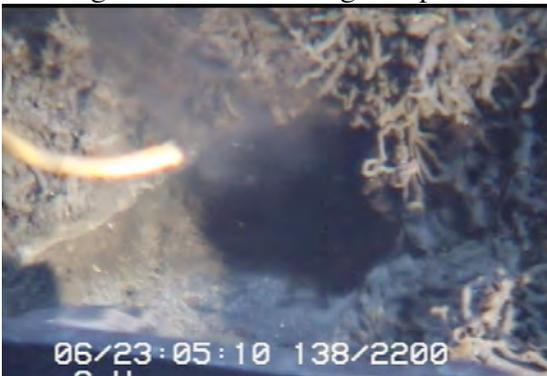
Frame grab #1327: reaming completed; close-up of drill hole

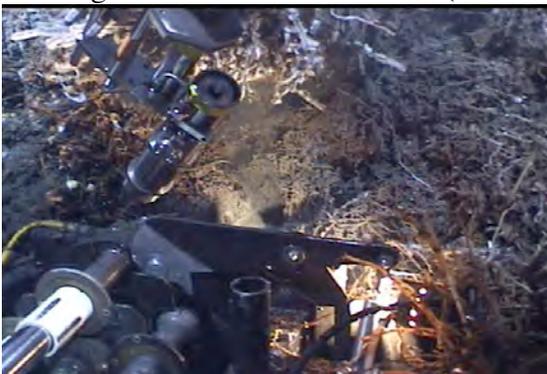
Frame grab #1338: same as above (far field view); gas-tight sample in progress.

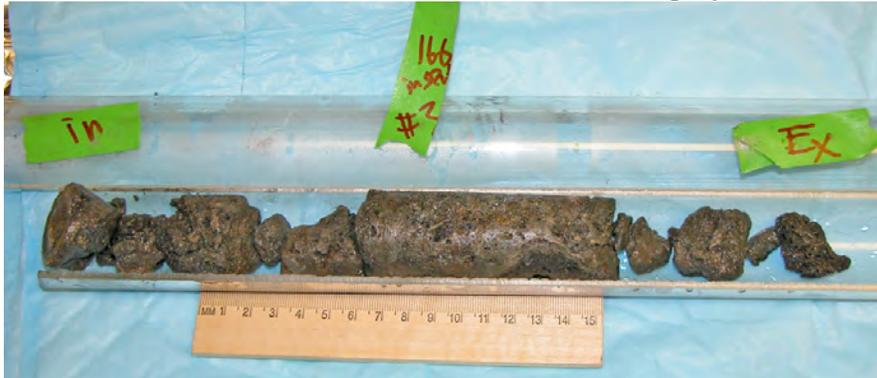
J166\_090605\_core2218 - drill core from insert#3 deployment into Hulk diffuse vent

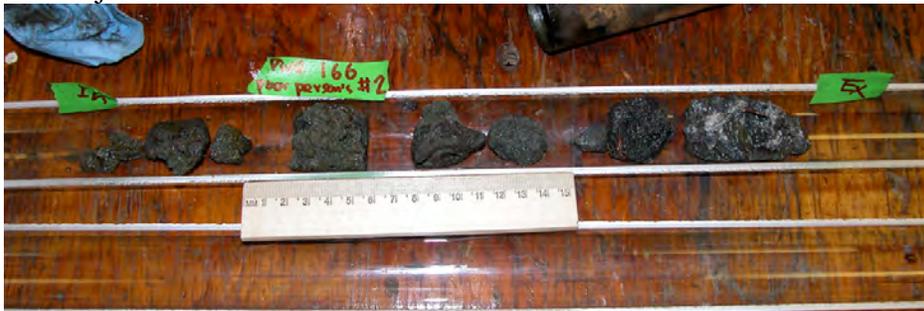
J166\_090705\_core0202 - drill core from poor man's#2 deployment into another Hulk diffuse vent adjacent to insert#3 site.

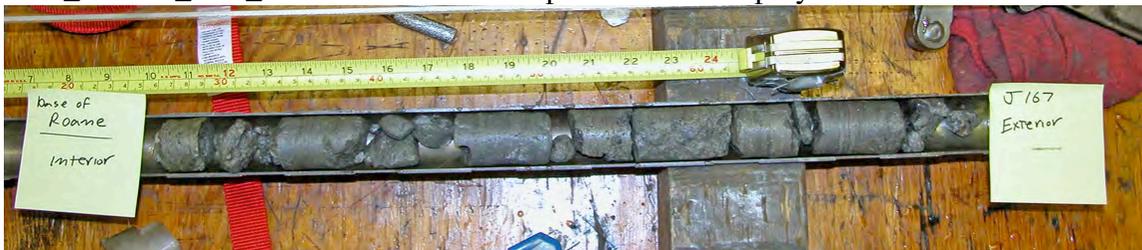
J167\_070905\_core\_1935 - drill core from poor man's#1 deployment into Roane base.

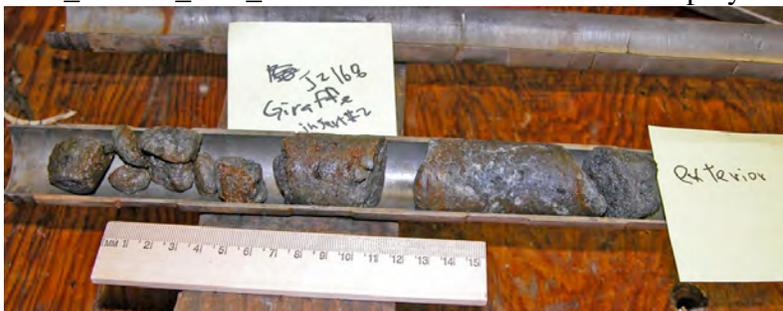
J168\_090805\_core\_0631 - drill core from insert#2 deployment into Giraffe.
